**Title:** Pre-CERCLIS Inspection for Loewenthal Metals Corp

**EPA ID:** ILP000510081

PRE-CERCLIS SCREENING ASSESSMENT

Loewenthal Metals Corp.  
947 W. Cullerton Street, Chicago, Illinois

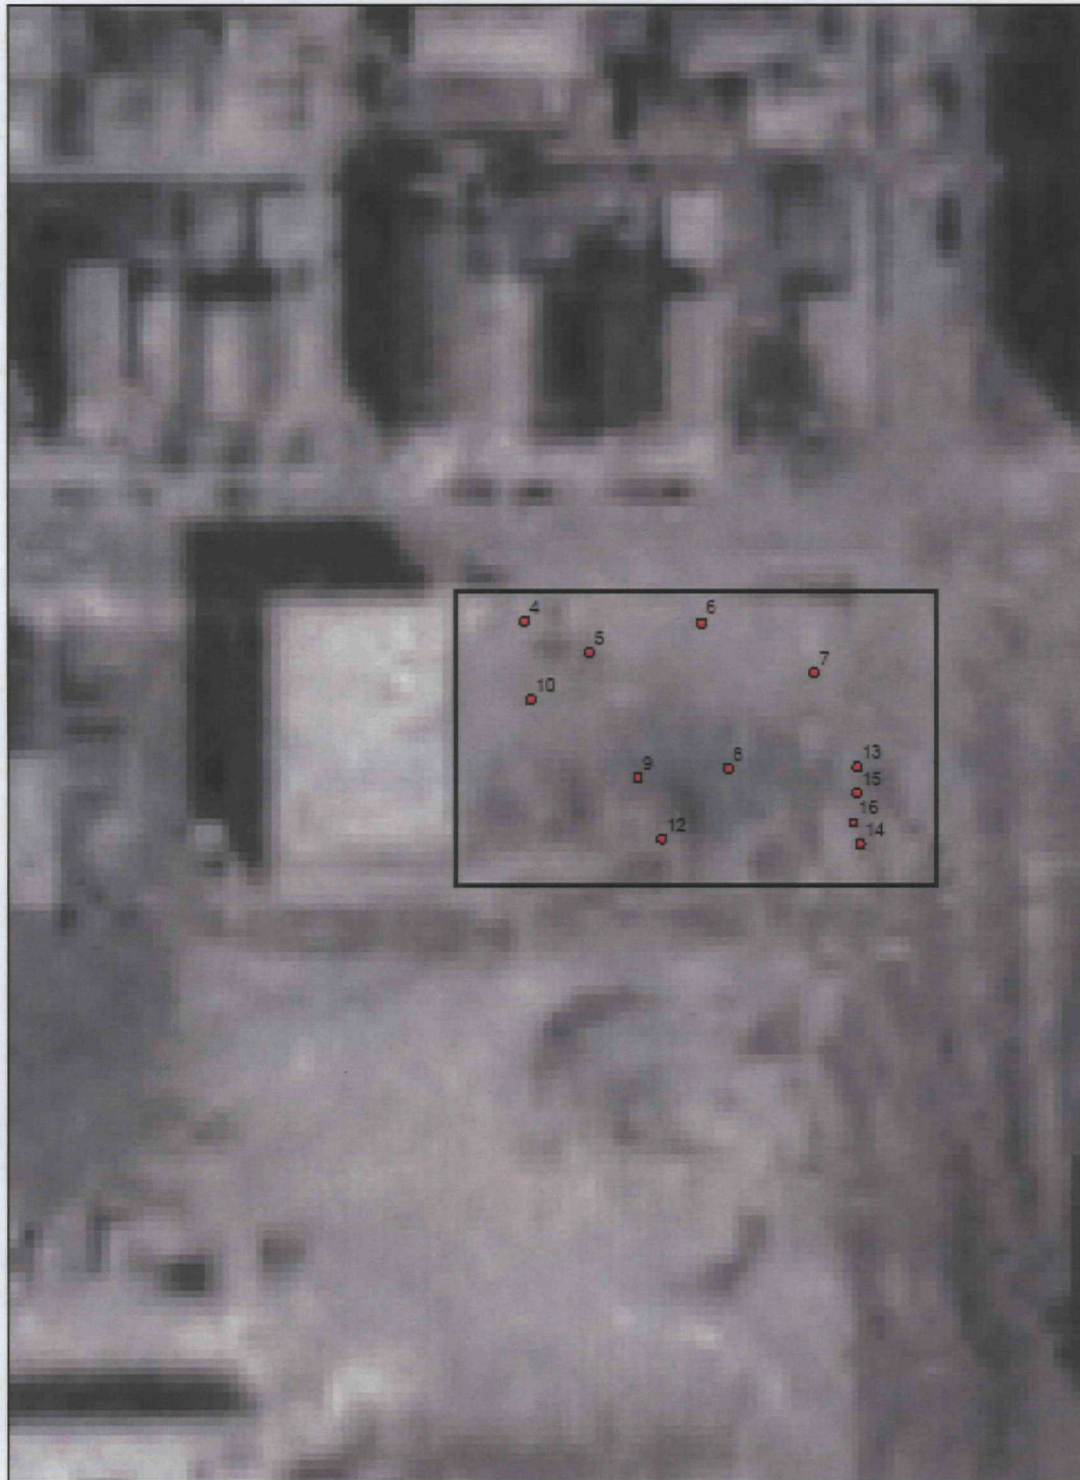
Figure 2  
XRF Locations

During the July 15<sup>th</sup> site inspection, a Niton X-Ray Fluorescence (XRF) analyzer was utilized to collect inorganic data to determine if any potential hazards can be associated with past operations of the lead smelter. Twelve XRF readings were collected from random locations (Figure 2). These readings revealed elevated levels of arsenic, lead, copper, manganese and zinc. These contaminants were found to be in excess of three times the background limits. Lead was found in excess of 400 parts per million (ppm). There are no established Removal Action Levels for lead. Many times if lead exceeds 400 ppm (set forth in Tiered Approach to Corrective Action Objectives, Tier I Values) then these areas are subject to removal actions. Background limits were established using *A Summary of Selected Background Conditions for Inorganics in Soil* (Ref. 8). These XRF readings are documented in Table 1.

XRF readings were collected in various areas of the site (Fig 2). These readings were collected to determine if inorganic contamination was present in the surface soils of the site. Surface soils with contamination could affect the individuals utilizing the area for possible recreational purposes and also pedestrians using the area as a sidewalk.

Results from the XRF readings revealed a number of locations that exceeded three times the background levels for lead, arsenic, copper, manganese and zinc. For arsenic, XRF 15 was the only location that exceeded three times the background levels. Lead results revealed XRF 5, 8-11, and 13-16 above three times the background levels. Copper was elevated in XRF 13-16. Manganese results revealed only XRF 7 being

elevated. Three times the background level of zinc was found in XRF 7, 9-11 and 13-16. A table of the XRF results can be found in Table 1.

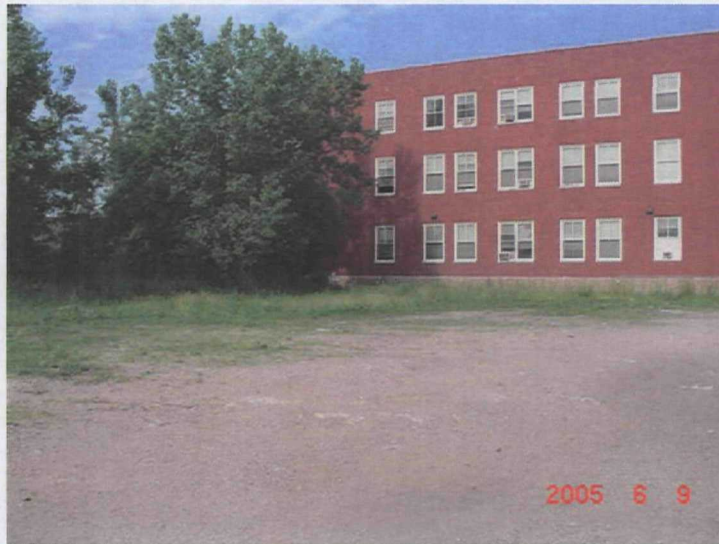
Date: 6/9/05
Time: 9:00 AM
Photo Taken By: Lance L. Range
Roll No. NA
Photo No. 1
Direction of Photo: West
Comments: Photo taken of vacant lot where former smelter used to be. As can be seen, lot is unvegetated and used for parking/possibly for pick up ball games. Low Rent housing in the background.

There is a residential apartment complex located directly to the west of the site (photo 1, page 11), with residential homes found adjacent (north) of the site (photos 6, 7 and 8, page 14 and 15). Rail road tracks are present on the east side of the site, followed by residential homes (photo 4, page 13).

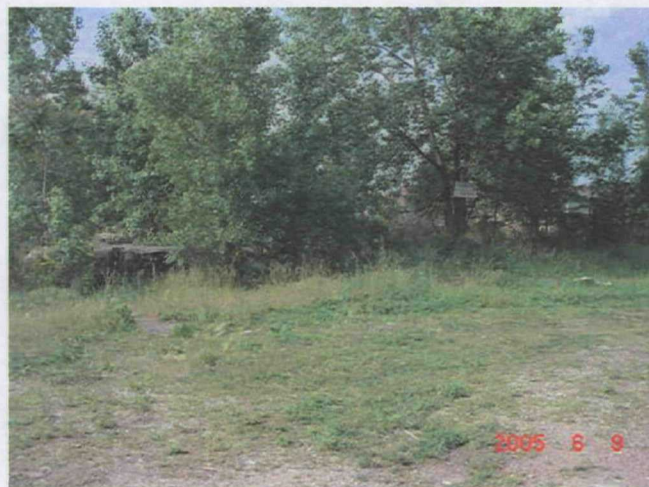
Date: 6/9/05
Time: 9:00 AM
Photo Taken By: Lance L. Range
Roll No. NA
Photo No. 2
Direction of Photo: South
Comments: Photo taken from middle of lot. There is a concrete structure present at the back of the lot. Railroad tracks are present in the trees also.

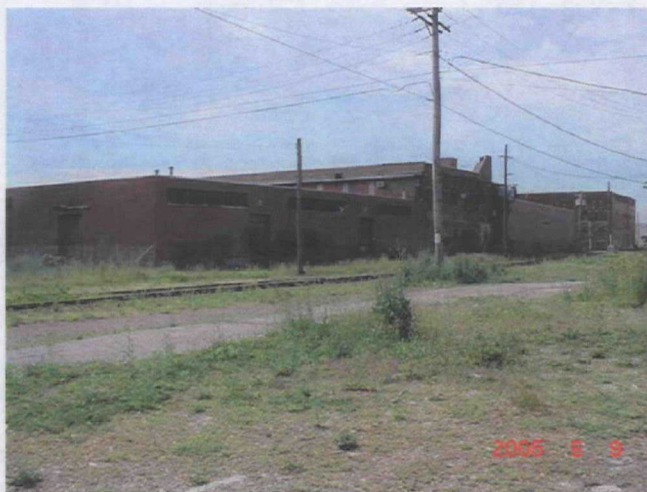
Date: 6/9/05
Time: 9:00 AM
Photo Taken By: Lance L. Range
Roll No. NA
Photo No. 3
Direction of Photo: SE
Comments: Photo taken from vacant lot, looking down the railroad tracks. Industrial complexes in the area.

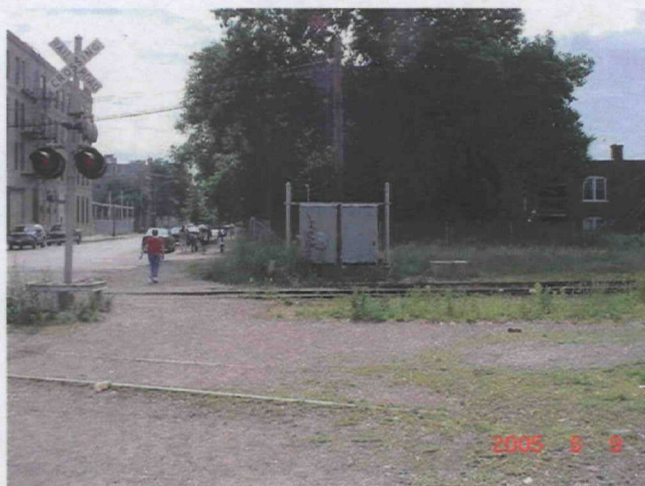
Date: 6/9/05
Time: 9:00 AM
Photo Taken By: Lance L. Range
Roll No. NA
Photo No. 4
Direction of Photo: East
Comments: Photo taken from the lot looking east. Beyond the RR tracks are residential homes and a school on the far corner. Many people walking on the site (no sidewalk) to and from school.

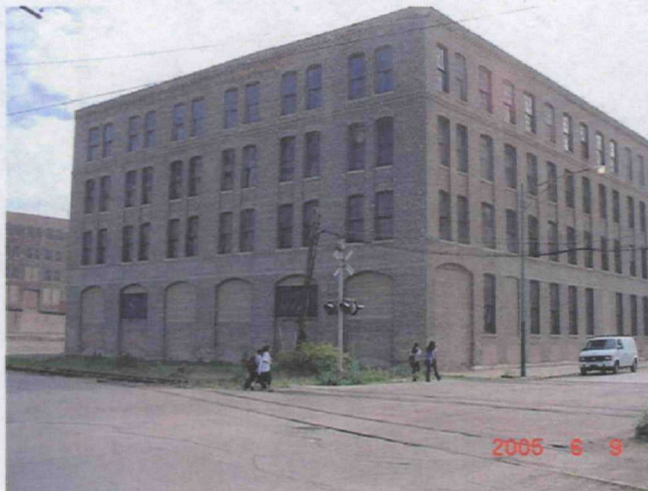
Date: 6/9/05
Time: 9:00 AM
Photo Taken By: Lance L. Range
Roll No. NA
Photo No. 5
Direction of Photo: SW
Comments: Photo taken of building across the street. Unsure as to what this building is used for. But the building looks taken care of.

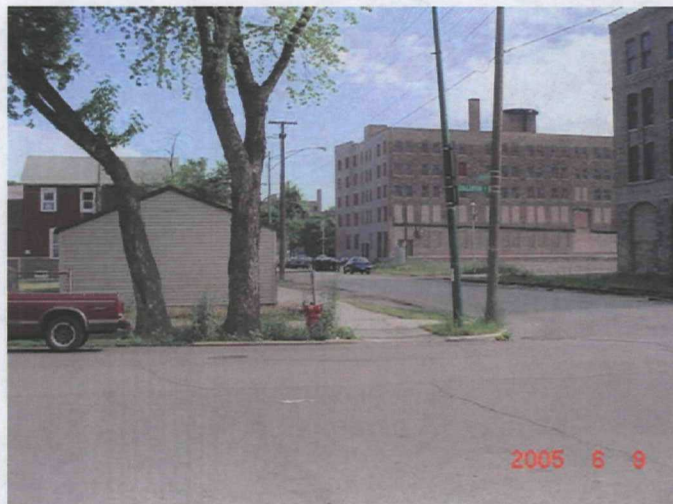
Date: 6/9/05
Time: 9:00 AM
Photo Taken By: Lance L. Range
Roll No. NA
Photo No. 6
Direction of Photo: North
Comments: Photo taken from Cullerton looking north. Residential and industrial complexes present.

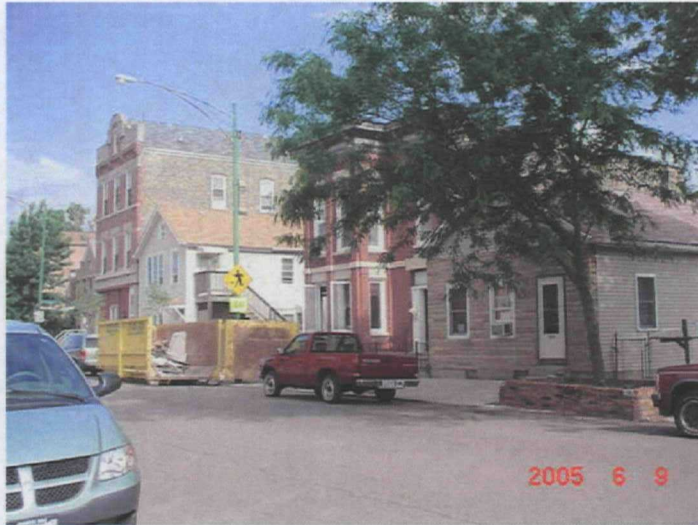
Date: 6/9/05
Time: 9:00 AM
Photo Taken By: Lance L. Range
Roll No. NA
Photo No. 7
Direction of Photo: SW
Comments: Photo taken of residential properties located across the street from the former smelter.

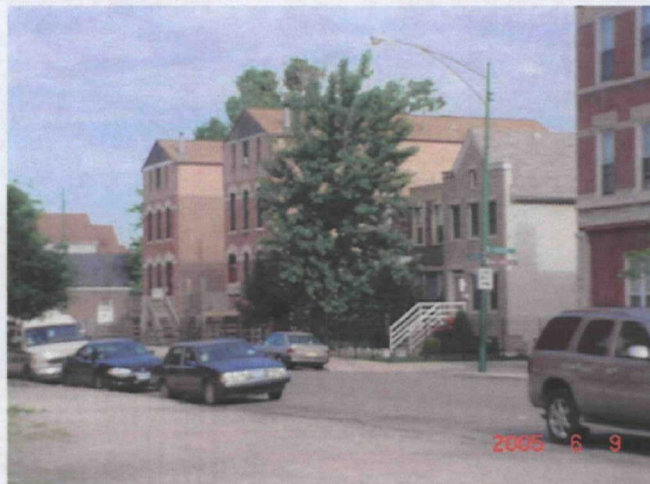
Date: 6/9/05
Time: 9:15 AM
Photo Taken By: Lance L. Range
Roll No. NA
Photo No. 8
Direction of Photo: West
Comments: Photo taken of more residential buildings further down the street from the former smelter.

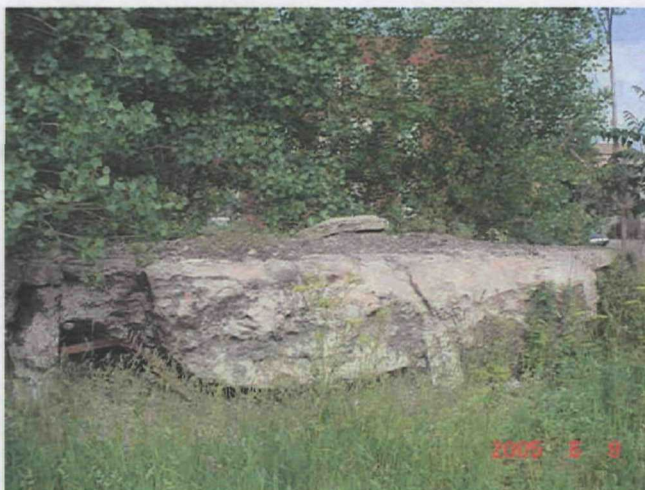
Date: 6/9/05
Time: 9:00 AM
Photo Taken By: Lance L. Range
Roll No. NA
Photo No. 9
Direction of Photo: west
Comments: Photo taken of the concrete platform located near the southern portion of the site. It is unclear if this structure was from the smelter or if some other type of building used for railroad purposes.

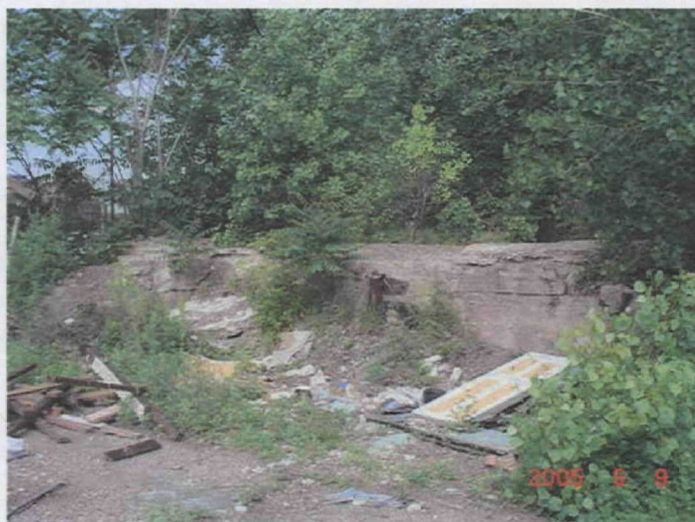
Date: 6/9/05
Time: 9:15 AM
Photo Taken By: Lance L. Range
Roll No. NA
Photo No. 10
Direction of Photo: South
Comments: Photo taken of the concrete platform. As you can see there is a dumping problem also in this area.

A reconnaissance trip was taken on July 15, 2006 to verify the conditions and locations of the former Loewenthal Metals Corporation. The site is presently an empty lot with a concrete platform in the southern portion of the site. There is also evidence of open dumping on the property (photo 10, page 16). A new residential complex has recently been built just west of the vacant lot (photo 1, page 13). To the east of the lot are railroad tracks followed by residential homes. The site is partially vegetated with exposed gravel and soil. Upon arriving at the site, it was determined that the southern edge of the property is being used for a walkway for children to and from school. There is not a sidewalk on the edge of this property. The presence of a tent/home-made structure near the south portion of the site indicated that the site is also being utilized by transient individuals.

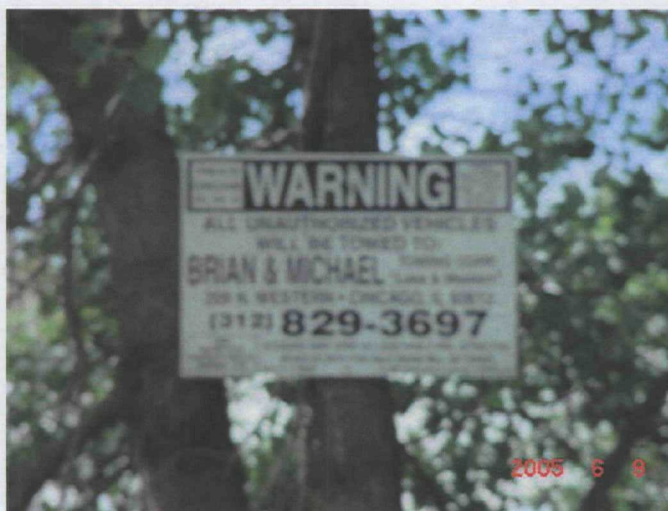
Date: 6/9/05
Time: 9:00 AM
Photo Taken By: Lance L. Range
Roll No. NA
Photo No. 11
Direction of Photo: South
Comments: Photo taken of the sign warning of parking onsite. Contact number for the towing company.
